ASSESSMENT

PHASE III  
- FINAL REPORTS -

**AIM III FINAL REPORTS**

**PLATFORM "C"**  
**INTACT AND DAMAGE CONDITION ASSESSMENTS**

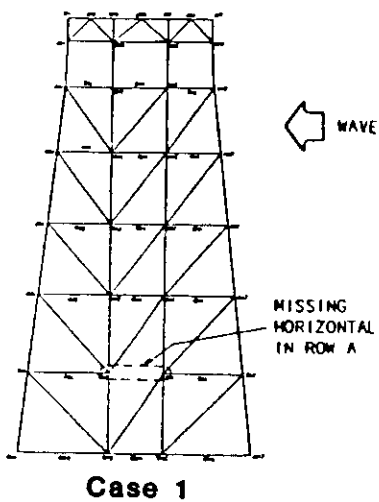
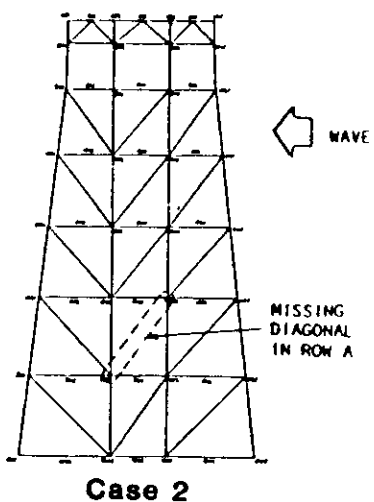
**FIGURE 2-1 SUMMARY OF DAMAGED CASES**

**Damage Near Base of Jacket:** Completely severed members caused by dropped objects from topside operations. Platform capacity dropped by about 10 to 12 percent.

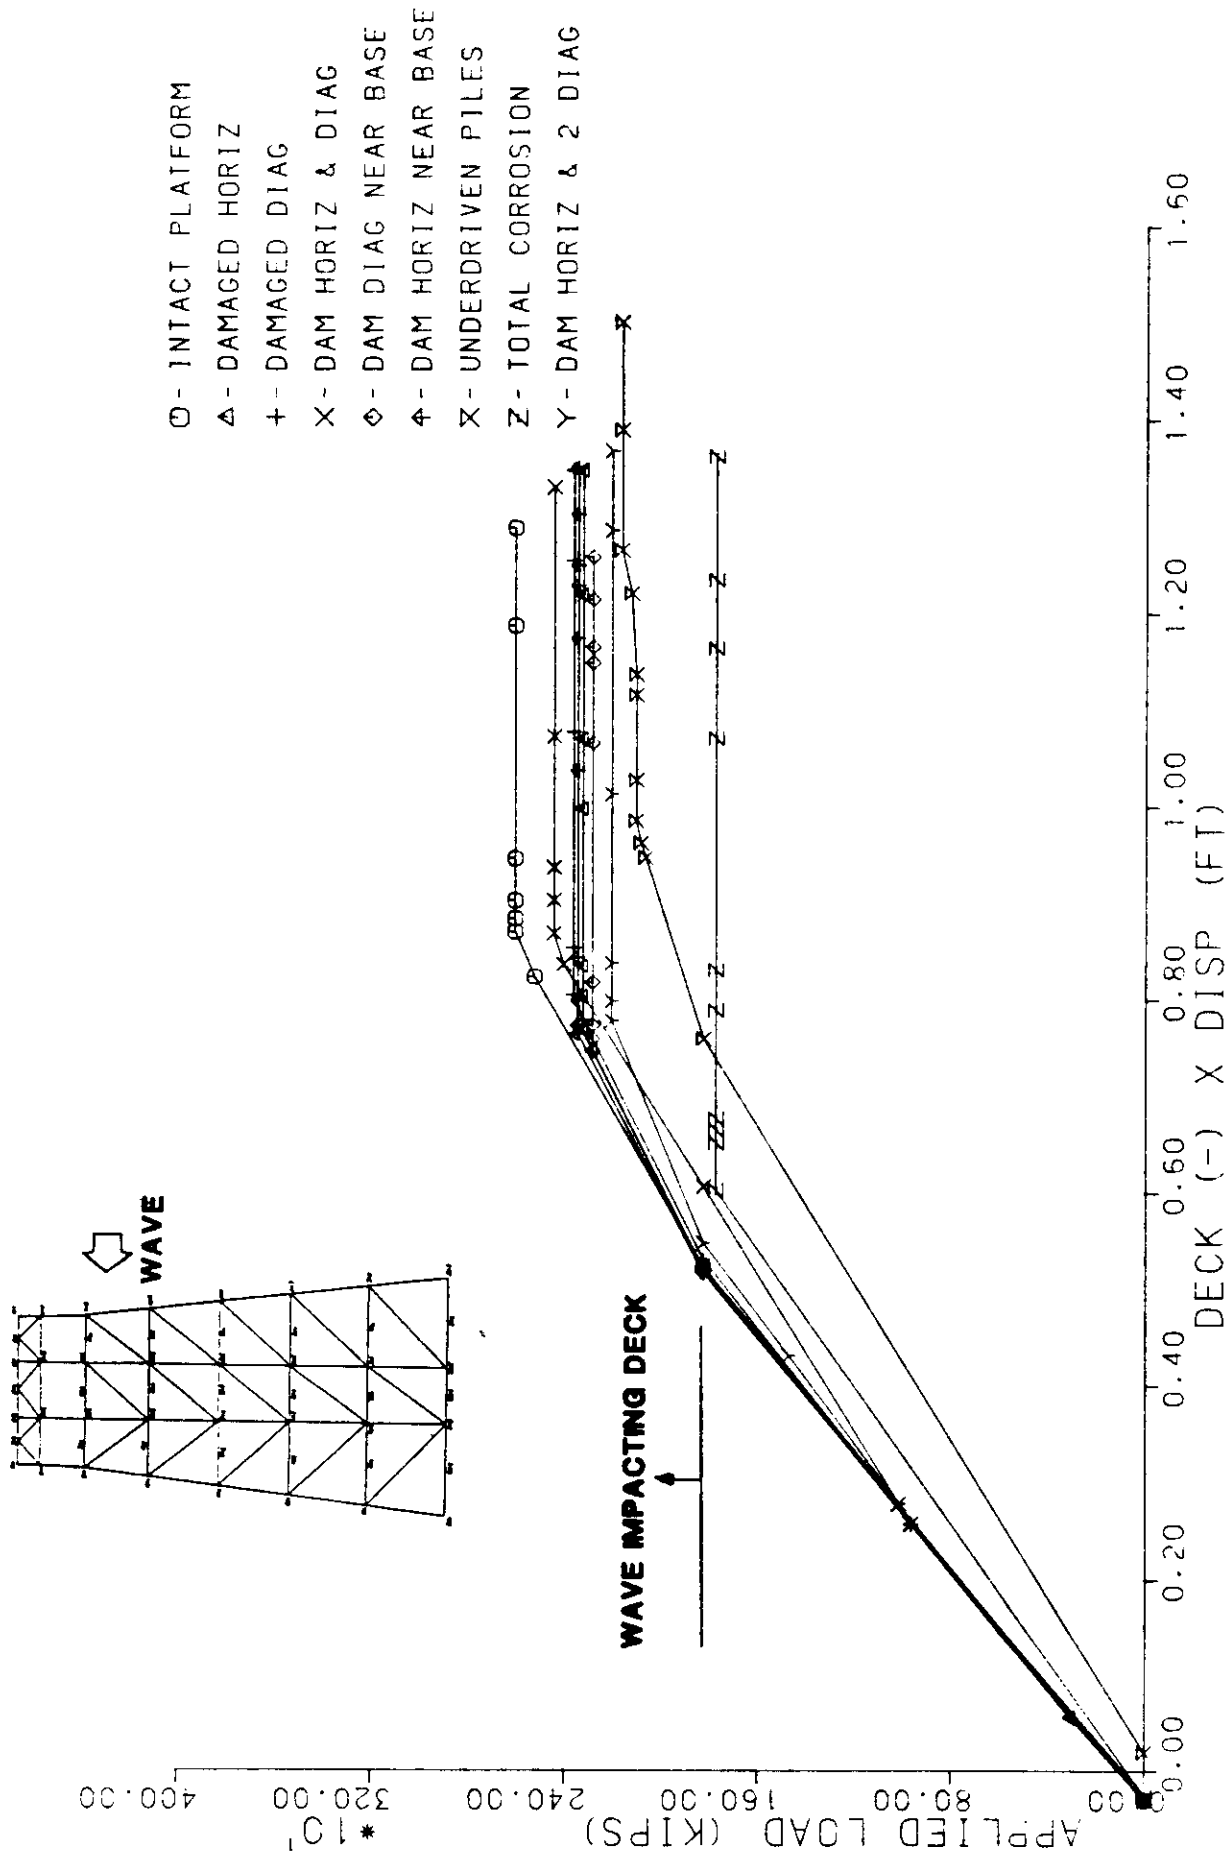
**FIGURE 2-2**

The general response of the platform for the damaged conditions is shown in Figures 2-2 and 2-3. The platform's performance is measured as a function of the applied horizontal environmental load and the deck

**EFFECT OF DAMAGE CONDITIONS - END-ON LOADING**

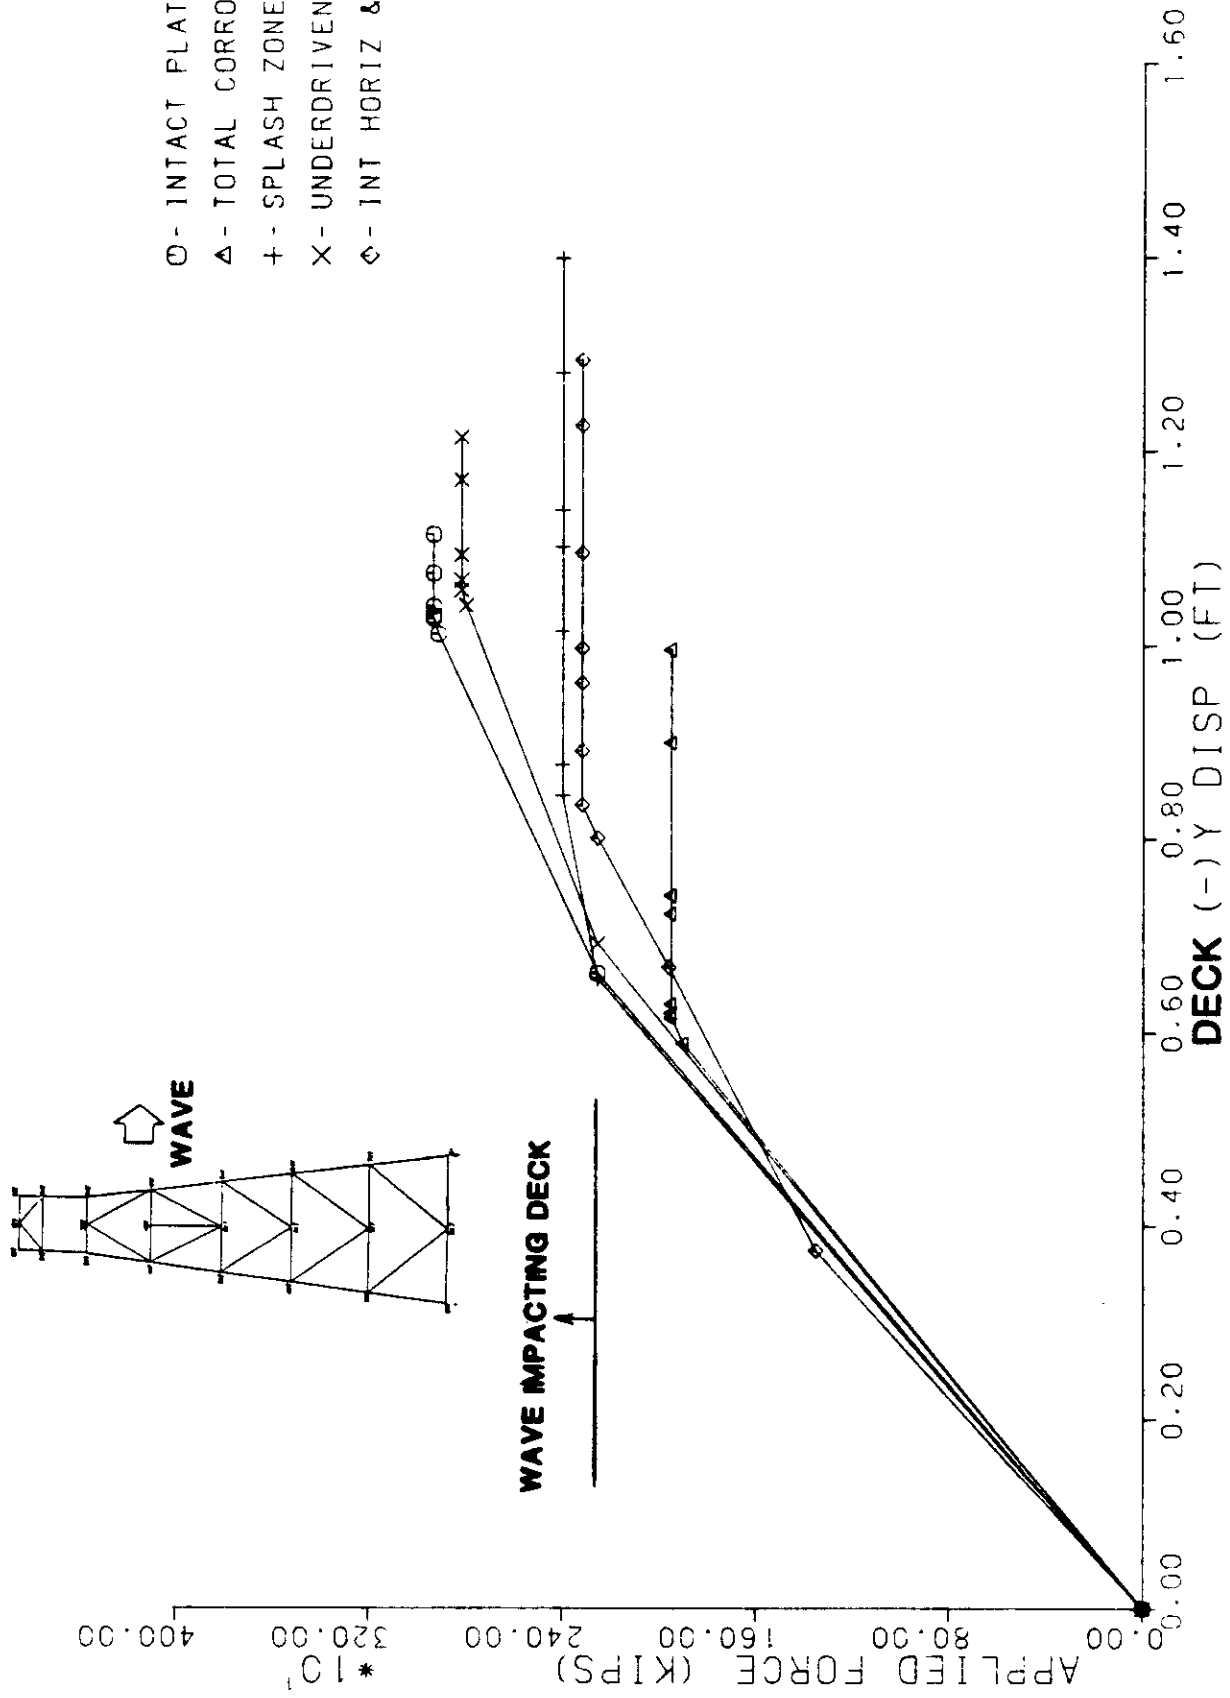
**FIGURE 2-3**

**EFFECT OF DAMAGE CONDITIONS - BROADSIDE LOADING**

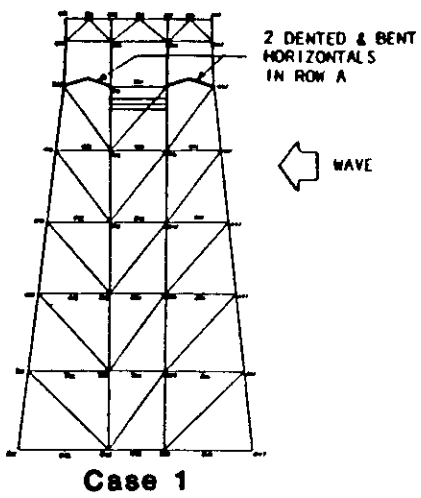
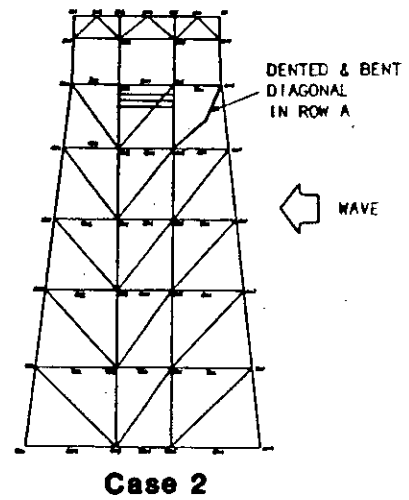
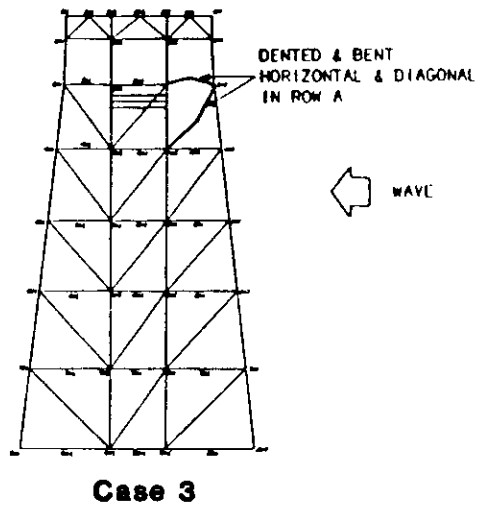
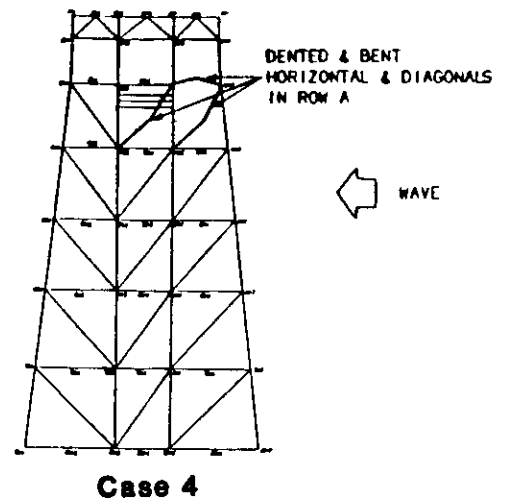
### DAMAGED MEMBERS NEAR WATERLINE

**Damaged Members Near Waterline:** Bent and dented members caused by workboat impacts. Platform capacity dropped by about 5 to 15 percent depending primarily upon the number of damaged members.

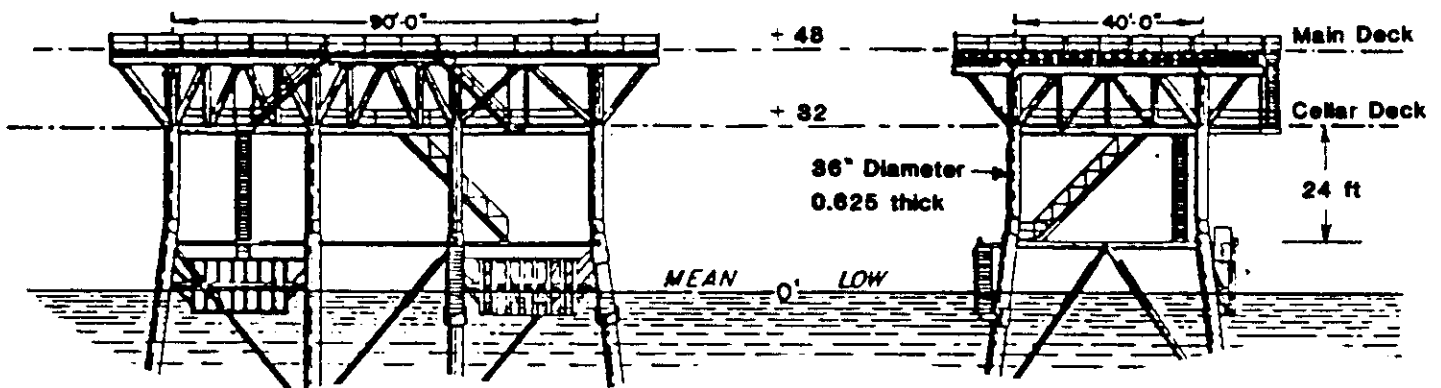
FIGURE 7-14

Figure 7-14 shows some details of the platform's deck. The platform supports three wells. The main deck (116 ft by 66 ft) is located 48 feet above mean Gulf level (MGL). The cellar deck (60 ft by 40 ft) is located 32 feet above MGL. The platform is oriented with its long axis in a northeast-southwest direction.

## DETAILS OF PLATFORM DECK

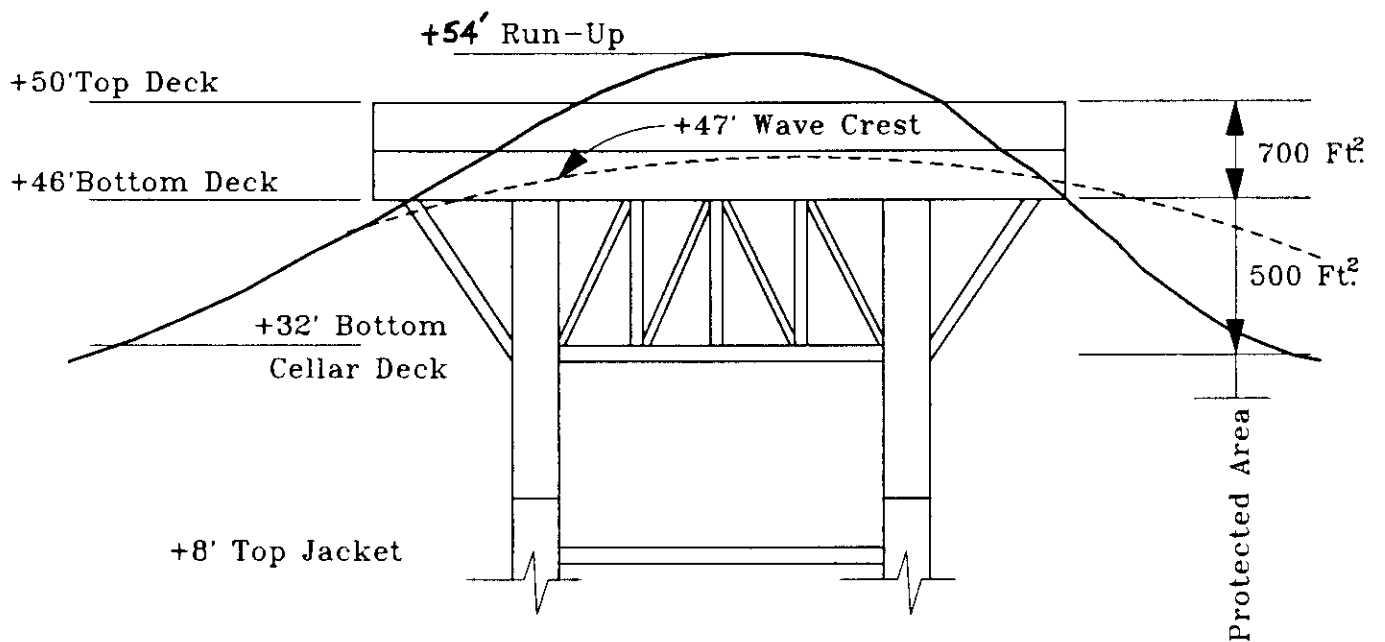
**FIGURE 7-15**

For a maximum wave height of 64 feet, the wave crest height would be about 45 feet ( $\eta_c = 0.7 H$ ) [22,23]. A storm time at the time of the maximum surge of 2 feet would indicate a wave crest elevation of +47 feet MGL (Figure 7-15).

With the bottom of the main platform deck located at +46 feet MGL, it would have been one foot into the maximum wave crest, and subjected to the wave run-up (Figure 7-6). It would also be subjected to the hurricane winds. The wind speed (1 minute average) was estimated to be 150 miles per hour at the time of the maximum wave.

The lower deck width was 60 feet. The projected (shadow) area of the lower deck, well-heads, conductors, equipment and facilities is 500 square feet (Figure 7-15).

The main deck width was 116 feet. As discussed later, the deck facilities height subject to wave run-up would have been about 7.6 feet. Thus, the projected area would be about 700 square feet (Figure 7-15).

**GEOMETRY OF PLATFORM, DECK, WAVE CREST,  
AND WAVE RUN-UP**

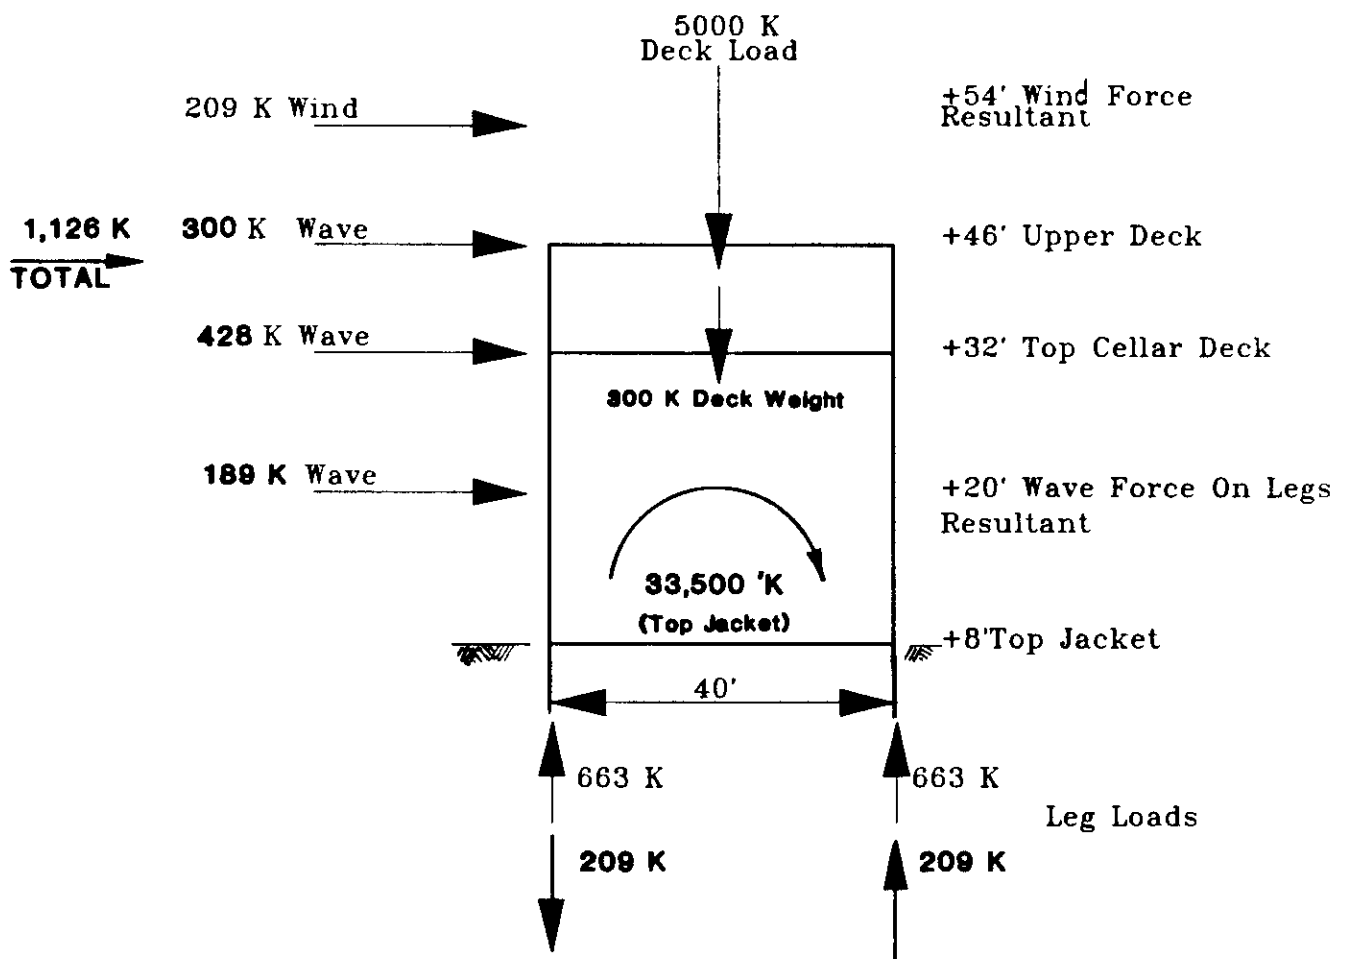
**FIGURE 7-16**

$$F_{TH} = 428 \text{ kips} \quad (\text{Figure 7-16})$$

$$F_{WH} = 209 \text{ kips} \quad (\text{Figure 7-16})$$

The total overturning moment,  $M_T$ , generated by this force system at the top of the jacket would be (Figure 7-16):

**WAVE, WIND AND DECK LOAD SYSTEM ACTING ON PLATFORM**

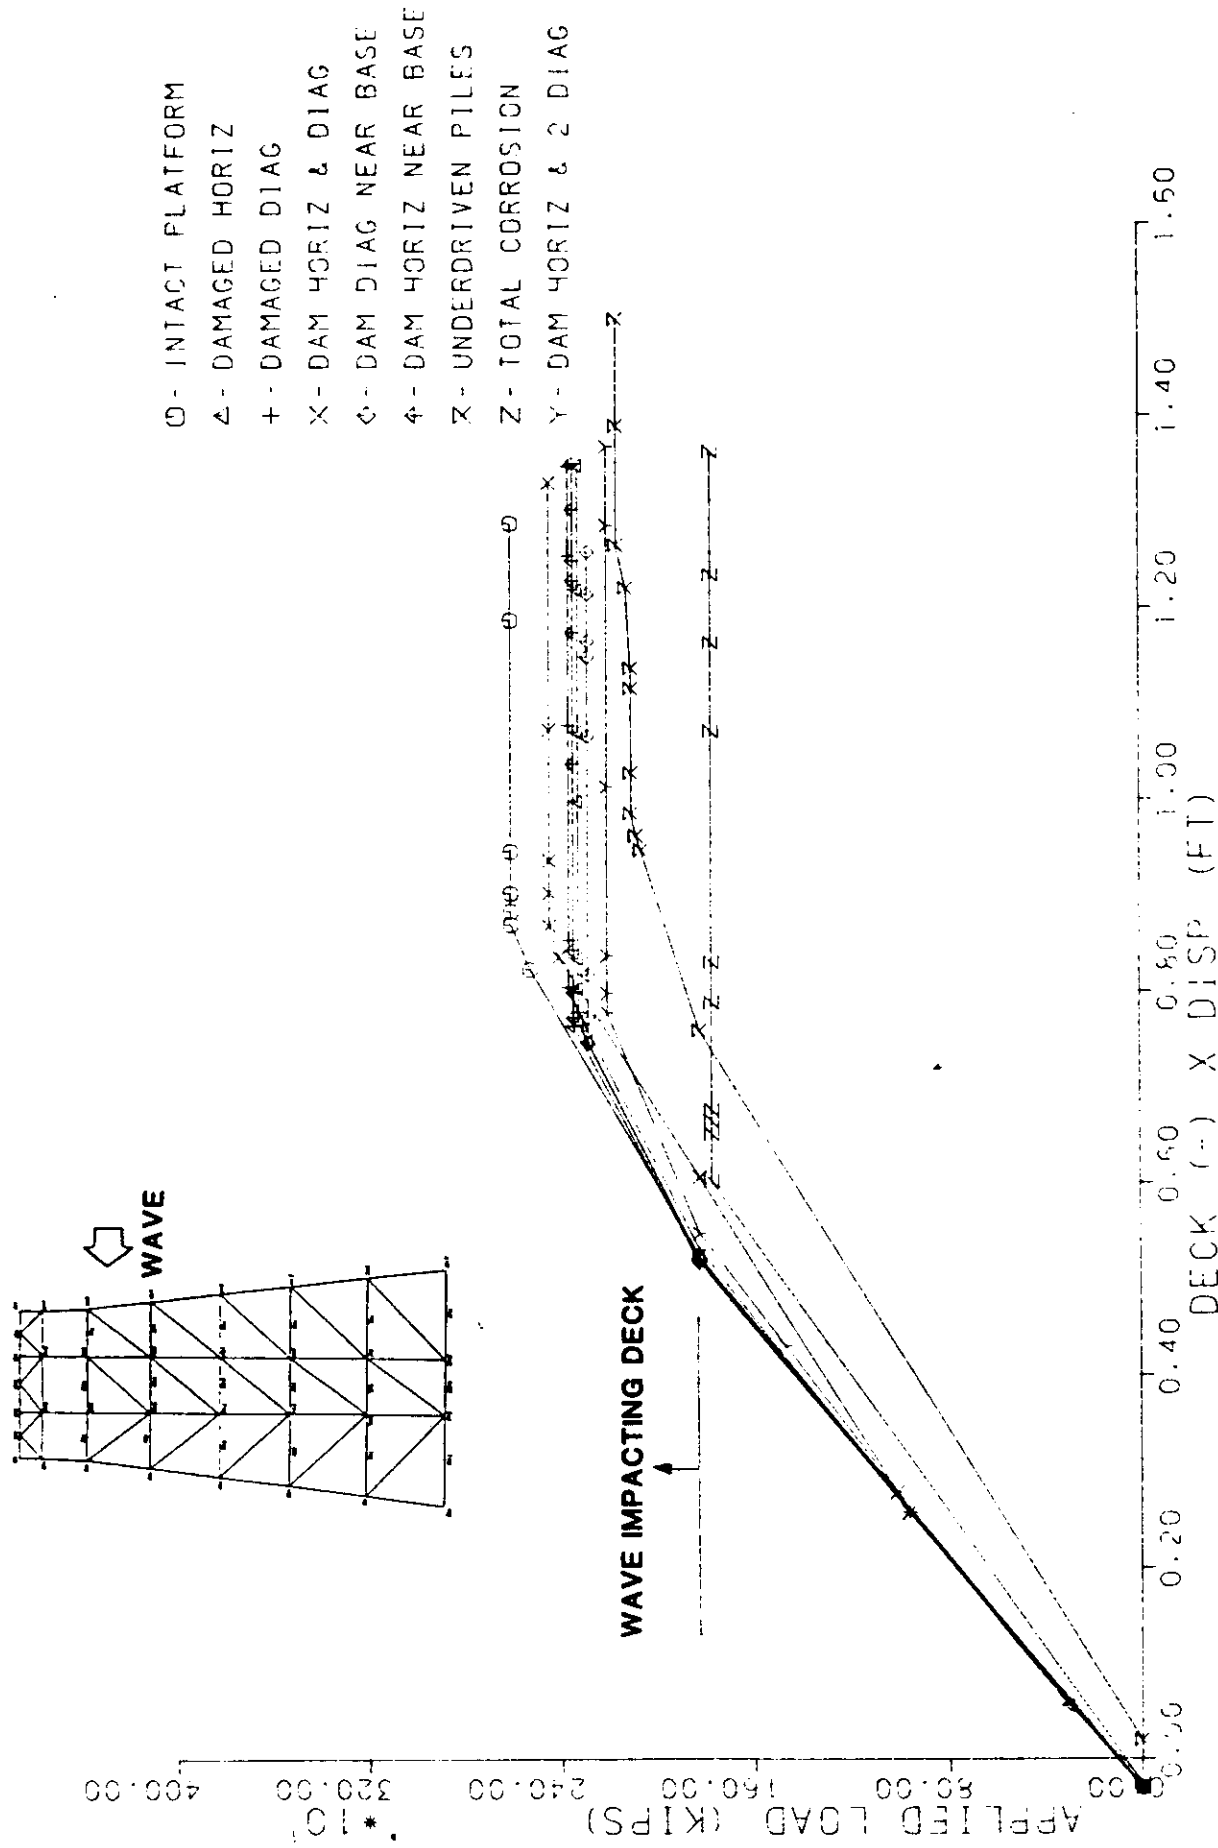
**FIGURE 8-1**

Figure 8-1 compares all of the damage cases against the intact case for wave loading in the end-on X-directions. The loading profile used in all of the analyses considered wave loading in the deck. Overall the damage cases did not severely influence the platform's response (e.g no capacity reductions on the order of 50 to 75 percent). The platform's capacity was reduced in all cases with a maximum reduction of about 34 percent caused by the overall platform corrosion condition. For this loading direction, the capacity did not drop below the 100 year wave force for any damage case. The platform appeared to be fairly resilient to the investigated damage conditions.

**SUMMARY OF DAMAGE CASE RESULTS FOR  
END-ON PLATFORM LOADING**

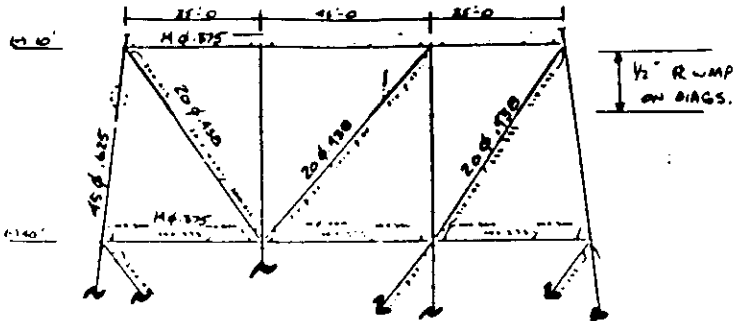
## CORROSION

### CONDITION:

- MAIN LEGS -  $\frac{1}{4}$ "
- ALL OTHERS -  $\frac{1}{8}$ "

## REDUCTION ON THICKNESS

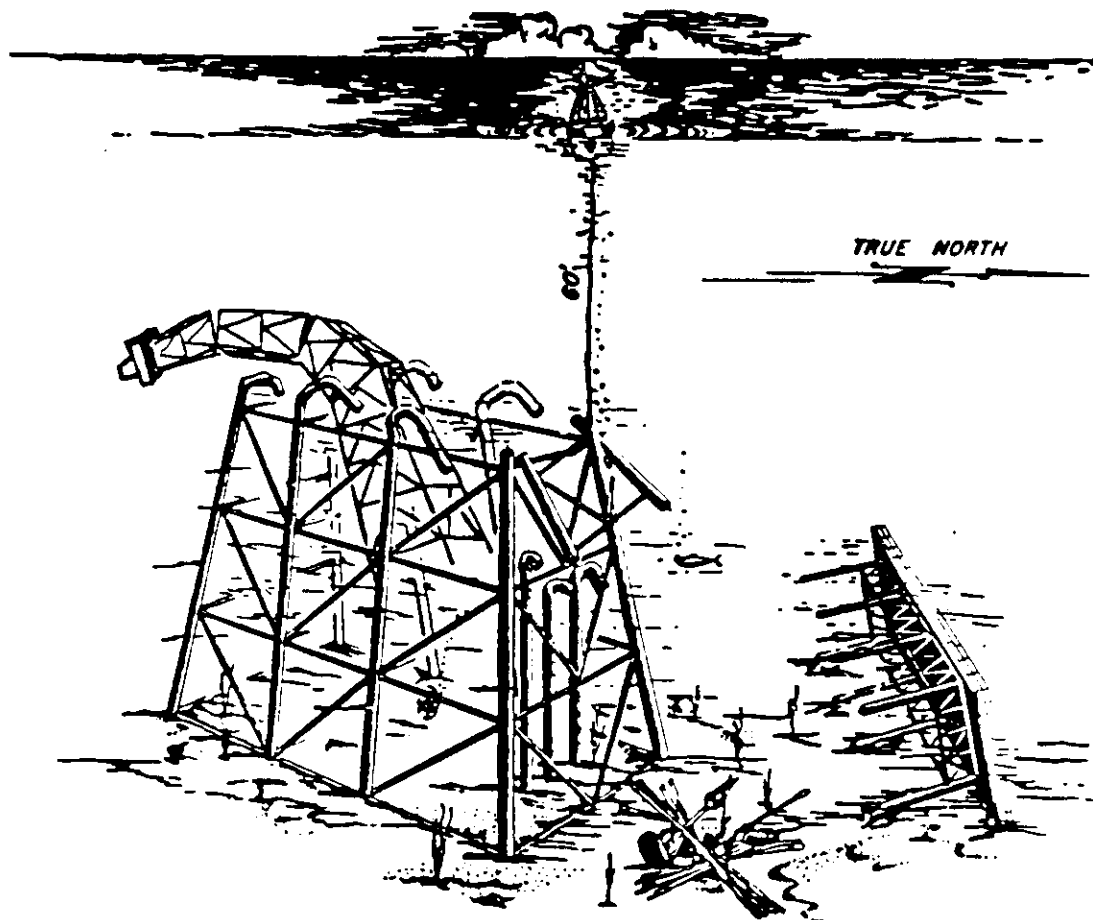
EUGENE ISLAND 276  
HILDA

SOURCE	DETAIL
WORLD OIL, 1964	UNION REPORTS IT WILL COST \$2 MILLION TO REDRILL WELLS IF THAT IS THE DECISION.
HILDA CONF. 1964	JACKET WAS PRETTY MUCH INTACT FROM -60' DOWN TO THE SEAFLOOR. ONLY ONE OF THE THREE WELLS DRILLED SO FAR HAD BEEN COMPLETED AND IT WAS NOT LEAKING.
OGJ, 10/12/64	BREWSTER-BARTLE RIG LOST WITH PLATFORM WAS WORTH MORE THAN \$1 MILLION. DRILLER WAS ON THIRD WELL WHEN STORM STRUCK.
OGJ, 11/9/64	UNION PLANS TO ABANDON THE 3 WELLS DRILLED FROM THE SUNKEN PLATFORM AND ERECT ANOTHER PLATFORM AT A NEW SITE IN THE SAME BLOCK.

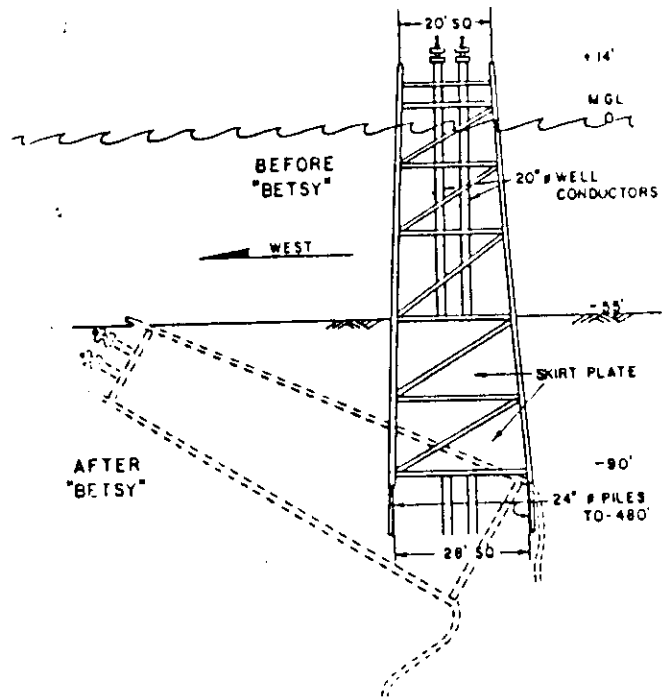
**SOUTH PASS 24**

SOURCE	DETAIL
BEA & AUDIBERT, 1980	MUDSLIDE FAILURE. STRUCTURE WAS FOUND TOPPLED OVER AND PUSHED BELOW THE MUDLINE. ONLY THE TOPS OF TWO LEGS AND THE TWO WELL HEADS COULD BE LOCATED.
BEA & AUDIBERT, 1980	DURING THE WINTER STORMS THAT FOLLOWED BETSY, CONTINUED MOVEMENT OF THE BOTTOM COVERED AND PUSHED THE STRUCTURE DOWN SO THAT IT COULD NOT BE LOCATED AGAIN.
BEA & AUDIBERT, 1980	FOLLOWING LOCATION OF THE STRUCTURE, THE WELLS WERE PLUGGED WITH CEMENT. NO LOSS OF HYDROCARBONS DUE TO DOWN-HOLE SAFETY EQUIPMENT.
LEE, G. 1988	JACKET FAILED UNDERWATER

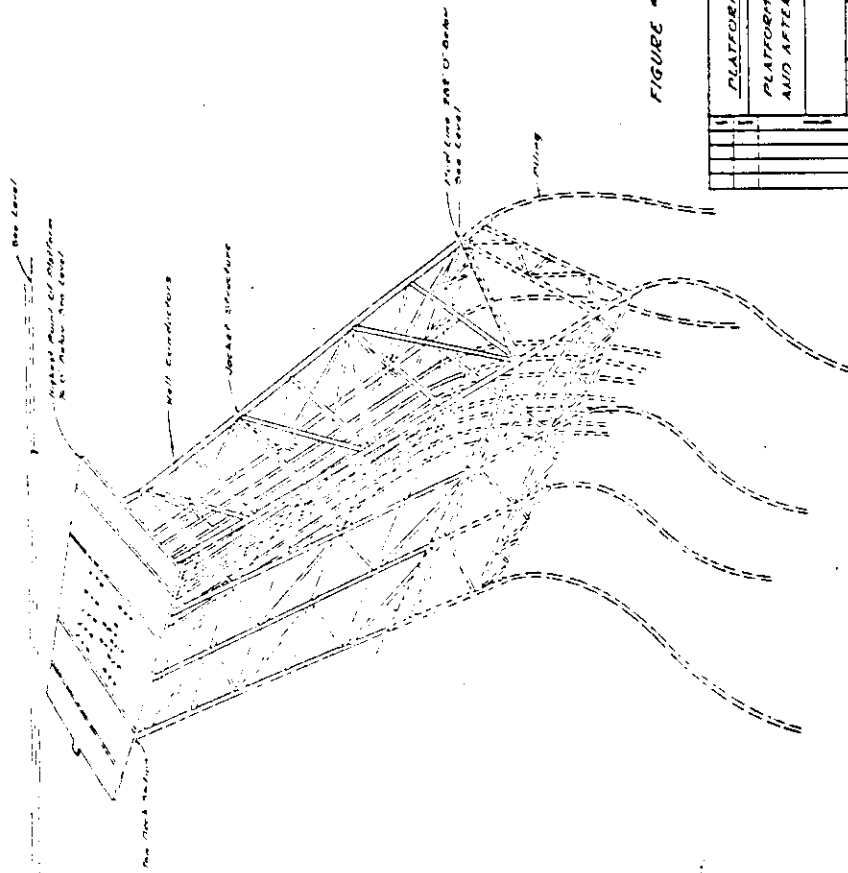
FIGURE #1

DAMAGED PLATFORM

PLATFORM 32 ALG/S/D		05-1411
PLATFORM CONDITION - BEFORE AND AFTER HURRICANE CAMILLE		
DATE	05-14-11	
BY		
CHECKED BY		
APPROVED BY

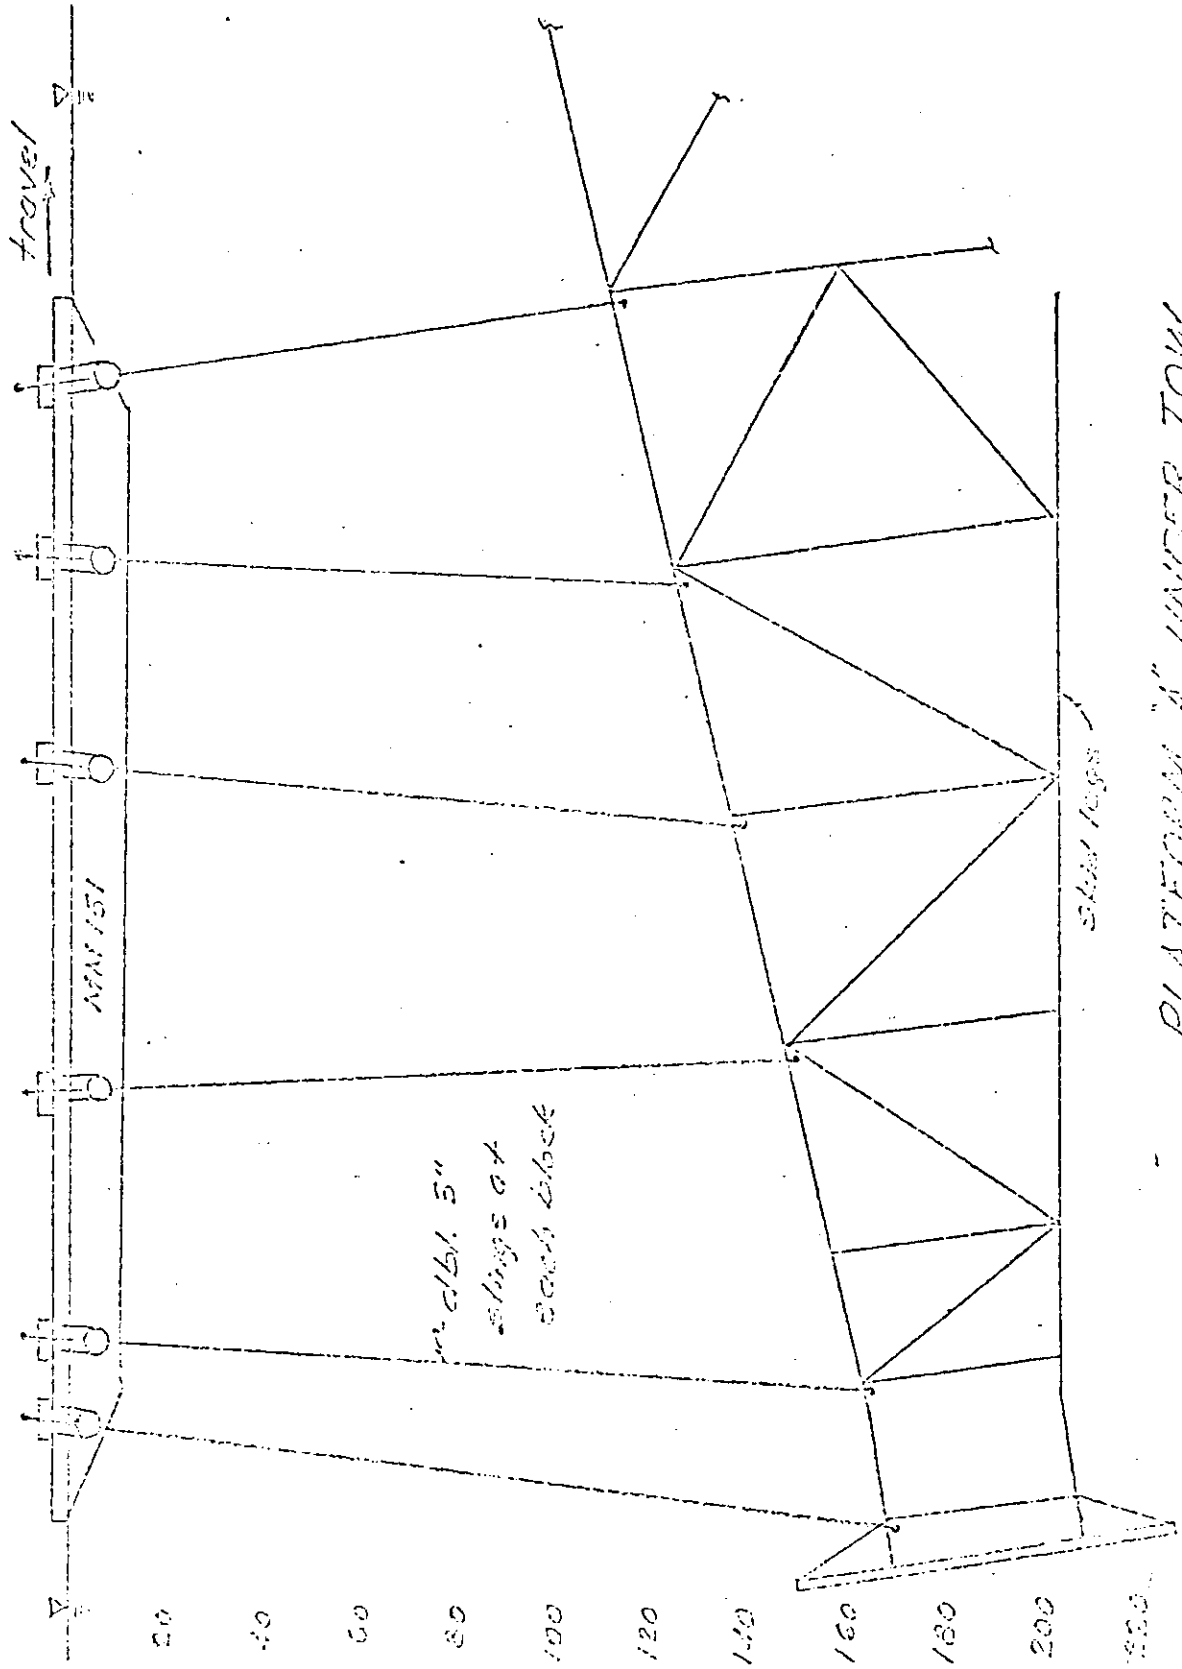
PLATFORM "A" UNDER TOW

SOUTH PASS 61-A CAMILLE TOWING PLATFORM FOR DISPOSAL

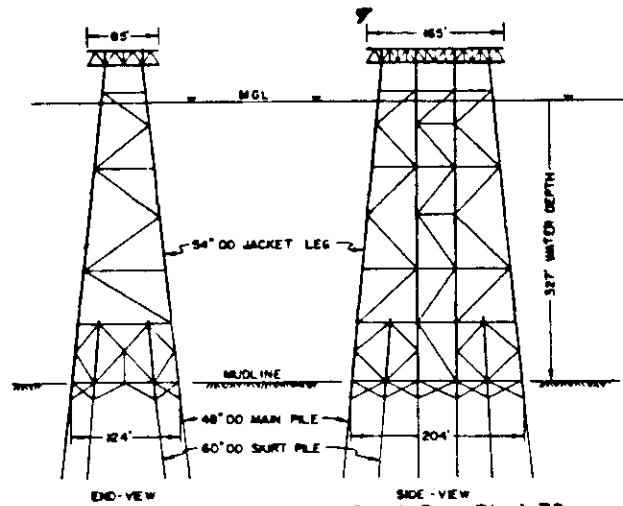
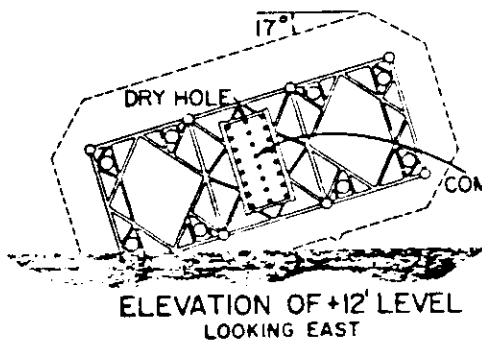
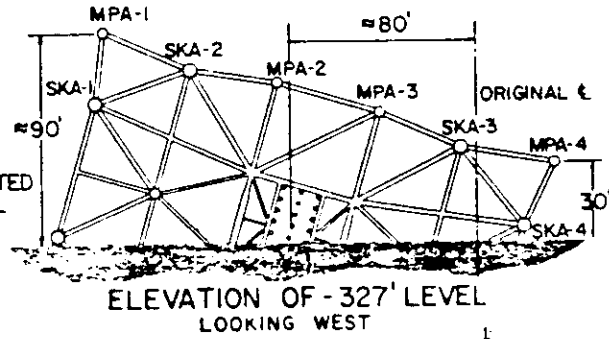
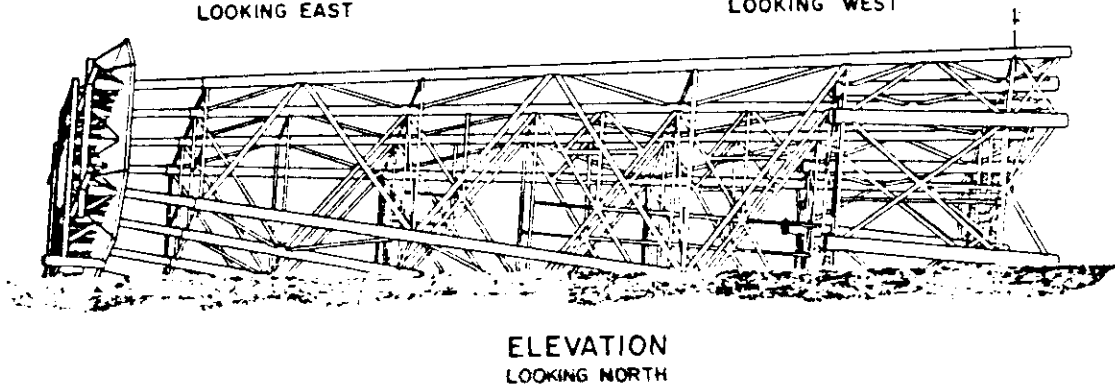
**SOUTH PASS 70-B**

SOURCE	DETAIL
STERLING, 3/80	PLATFORM FELL IN ONE PIECE TO SEAFLOOR WITH ALL BRACES INTACT. THE STRUCTURE WAS PARTIALLY BURIED IN THE MUD.
OGJ, 8/25/69	COLLAPSE DUE TO MUDSLIDE. SISTER PLATFORM AT 70-B REMAINED STANDING, BUT SEVERELY DAMAGED.
BEA, 1988	PLATFORM WAS EVENTUALLY CUT UP AND SALVAGED.
BEA, ET. AL., 10/80	PLATFORM FELL TO WEST AND MOVED DOWNSLOPE ABOUT 100 FT. PILES FILED IN BENDING. THERE WAS NO EVIDENCE OF PILE PULLOUT.

Side and end view, South Pass Block 70  
Platform B

South Pass Block 70 Platform B on the bottom.

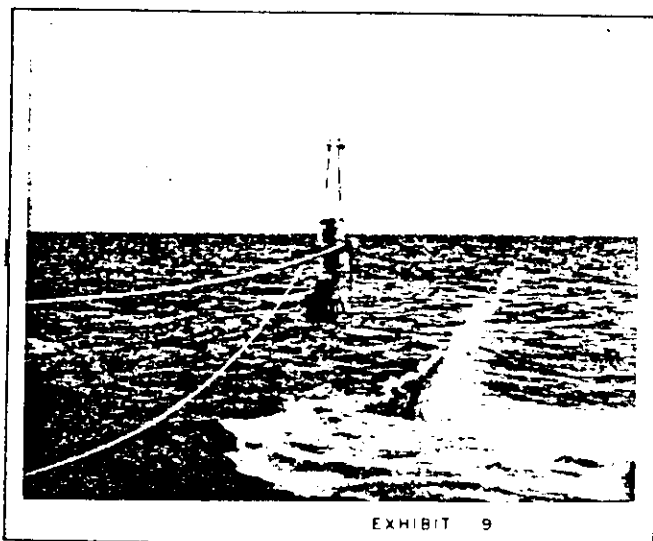
EXHIBIT 9

SOURCE	DETAIL
WORLD OIL, 10/65	THIS PLATFORM PLUS 117-A WERE PRODUCING 3000 BPD. IF GULF CAN'T RECOVER THE 15 WELLS, THEN MONETARY LOSSES WILL BE \$10 MILLION.
JEFFUS & STONER, '66	THE DECK SECTION WITH ALL ITS PRODUCING EQUIPMENT WAS SHEARED OFF AT OR NEAR THE JUNCTION BETWEEN THE DECK AND THE JACKET. THE JACKET WAS TILTED AT 70 DEGREES FROM VERTICAL.
CHEVRON, 1988	APPARENTLY NO BLOWOUTS OR SPILLS.
JEFFUS & STONER, '66	WELLS WERE P&A'D AND CUT DOWN TO M.L. IN 44 DAYS. THE PLATFORM WAS EVENTUALLY CUT UP AND SALVAGED FOR JUNK.

CAPING WELL

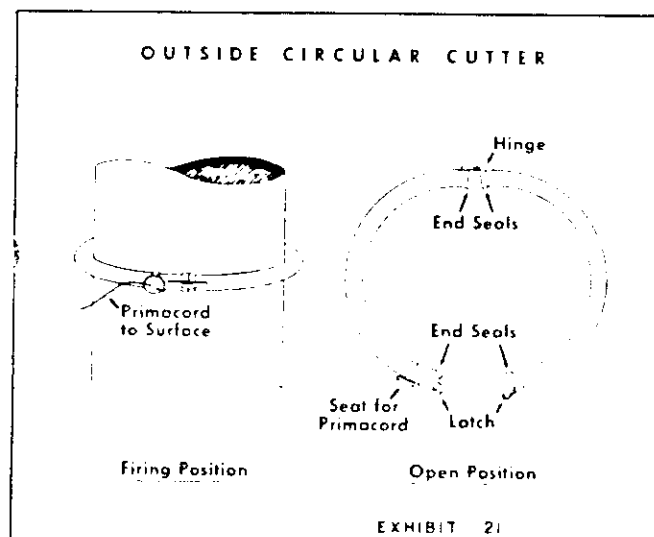
EXHIBIT 21

TUBULER EXPLOSIVE CUTTER

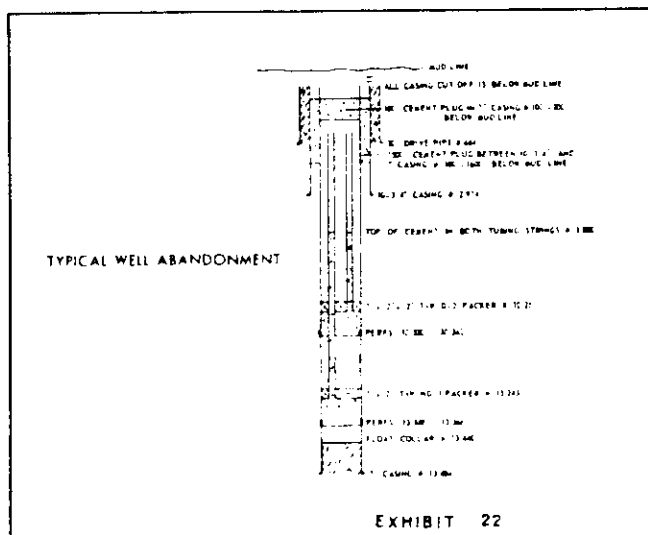
EXHIBIT 22

WELL ABANDONMENT

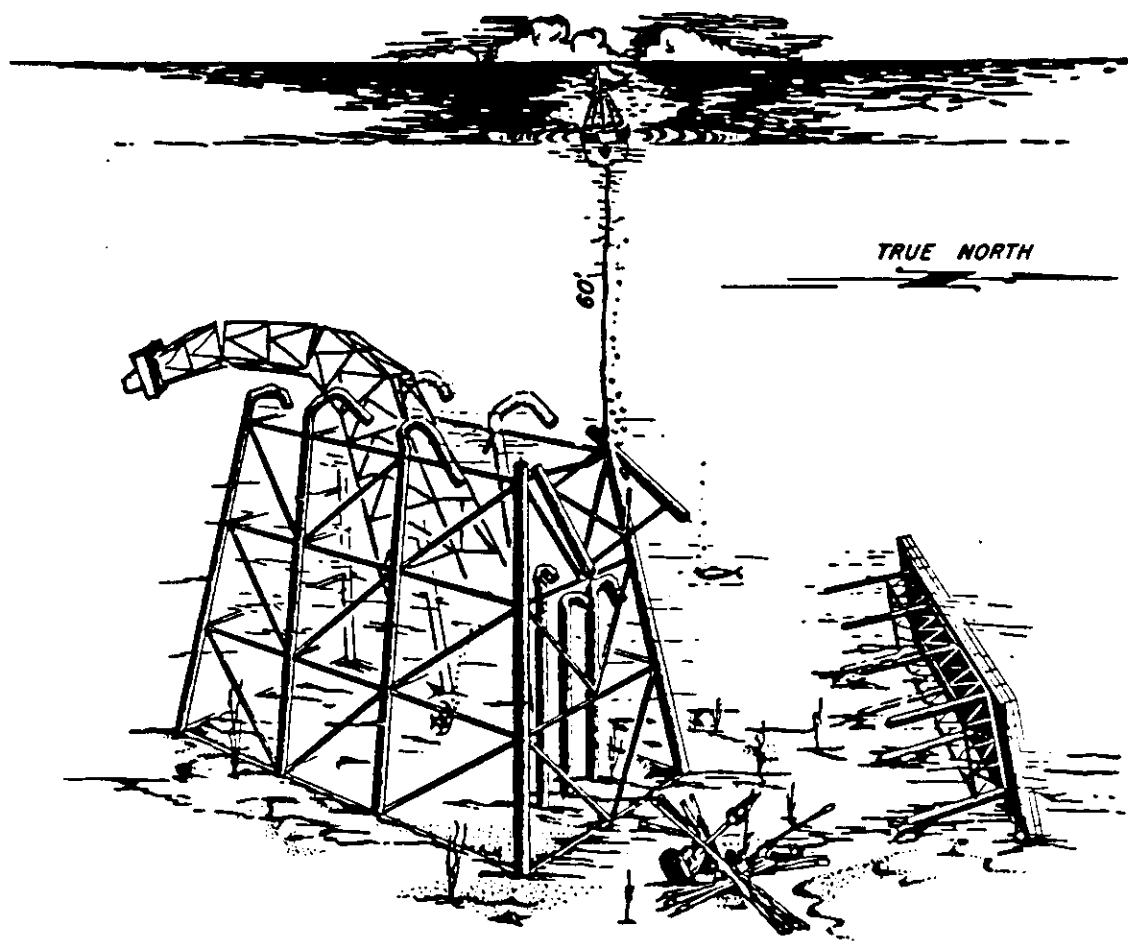
**Figure 5-3      Platform Loss of Serviceability Event During Hurricane "Hilda" (1964)**
